Lining Secondary Containment: It's in the Details

Sometimes it's the details that make the big things work—such as grinding key-in termination details all around a new secondary containment pad and applying the lining in the evening to mitigate outgassing from the new concrete.

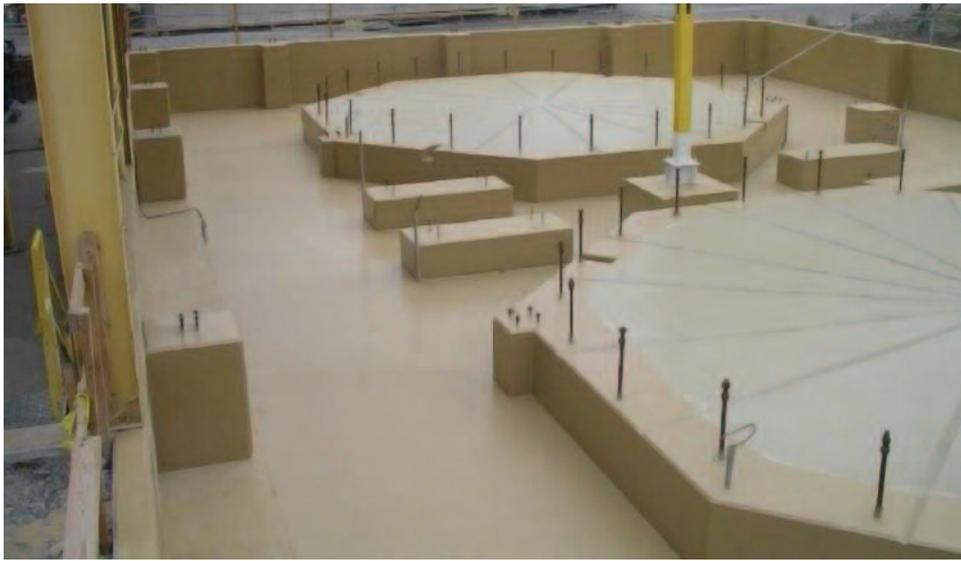
Courtesy of Coatings Unlimited, Inc.
